Inspection Order No. : IN-SH-5301-10194

INSPECTION REPORT

ALLOY STEEL SEAMLESS PIPE 34PCS

PETROLEOS DEL PERU- PETROPERU S.A AV.ENRIQUE
CANAVAL MOREYRA NO.150 LIMA 27
PERU

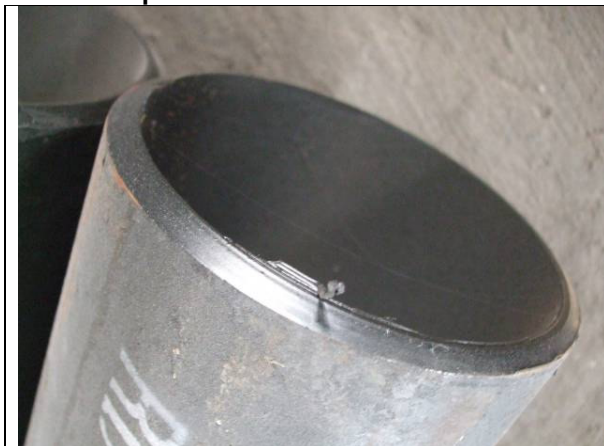
Slightly burrs were found at the one terminal of 3 PCS pipes

burr

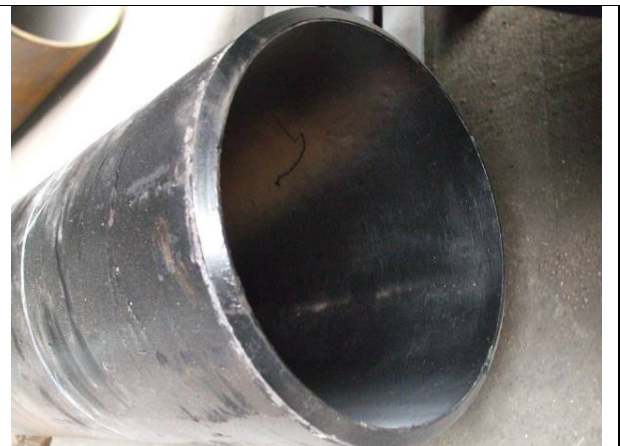
Both ends were groove angle cuts but in fact the square cuts is required as per purchase order N ° O/C ONO-10410016-OI page 4.

groove angle cut

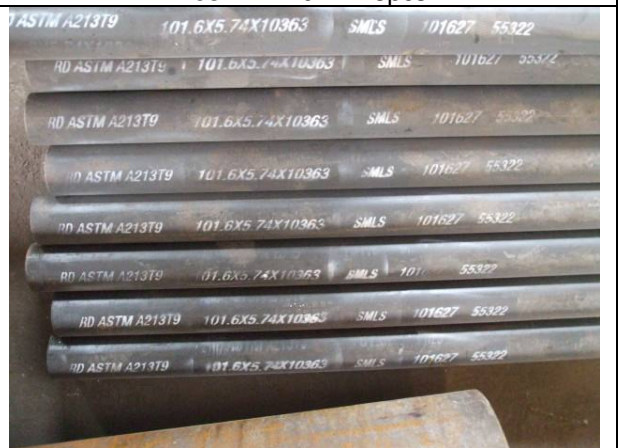
RD ASTM A213 T9 ***x***x*** SMLS *****x*****

The purchase order was not found on the body of pipes but in fact the purchase order should be showed as per purchase order N ° O/C ONO-10410016-OI page 4

marking

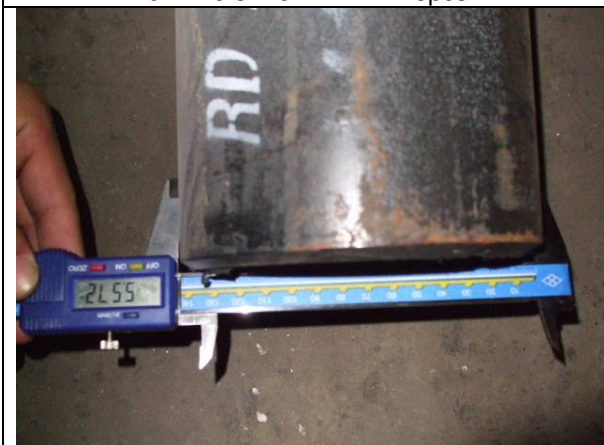
Dimension check

The required value was specified in purchase order N °O/C ONO-10410016-OI table 1 and the actual value were found met to the required values, the results were acceptable.
