INSPECTION REPORT N° : MDP/SH-13/076-001

PROJECT: N/A	Ref: MDP/SH-13/076
BV Client: CHENGDU DERBO STEEL CO.,LTD	P/o nr: (client to BV)
Manufacturer: CHENGDU DERBO STEEL CO.,LTD	P/o nr: SPRO/PO/13/1013(1)
Inspection requested by: CHENGDU DERBO STEEL CO.,LTD

SUPPLY / SUBJECT OF INSPECTION	ITEM / TAG Nr	INSPECTED QTY
API 5L SMLS PIPE 114.3*13.49mm PLS2, Gr.B, 3PE PROJECT: C.BN.CCS.DL.08.001.1231N-WELL TIE IN PROJECT	Pipe No from 001~212, For detail see packing list	212 PCS 2500.8 m

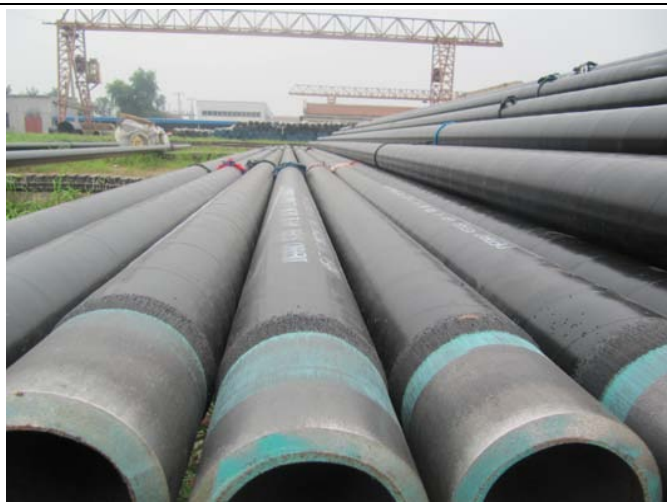
All the pipes had been finished manufacturing and stored in coating mill outside yard before BV inspector arrived site.

Pipe storage status

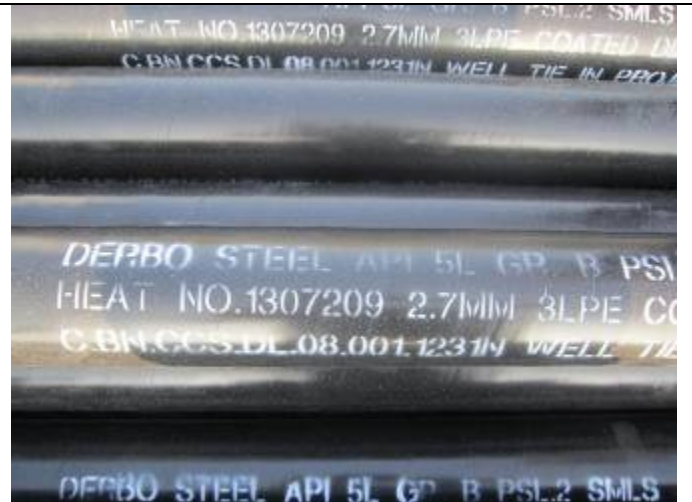
BV checked the pipe marking during this inspection, the marking content is DERBO STEEL API 5L GR.B PLS 2 SMLS 4"Xsch160X11.8M HEAT NO 1307209 2.7MM 3LPE COATED DIN30670 C.BN.CCS.DL.08.001.1231N WELL TIE IN PROJECT. The inspection result is acceptable.

Pipe making

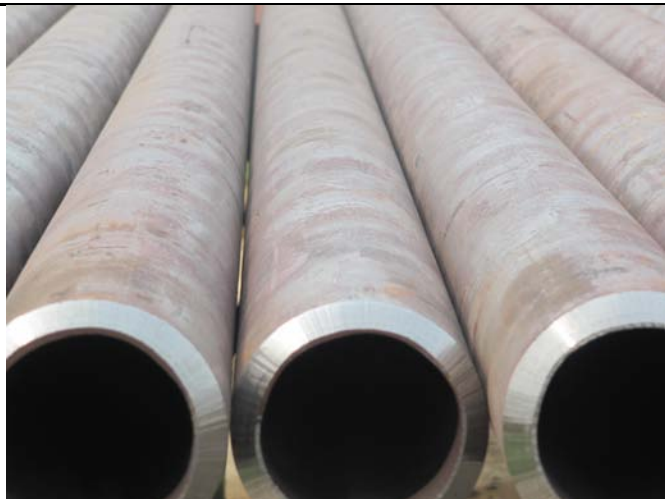
BV inspector checked the inner surface and pipe cutback area surface, include bevel quality, the surface quality is acceptable.

Pipe end bevel

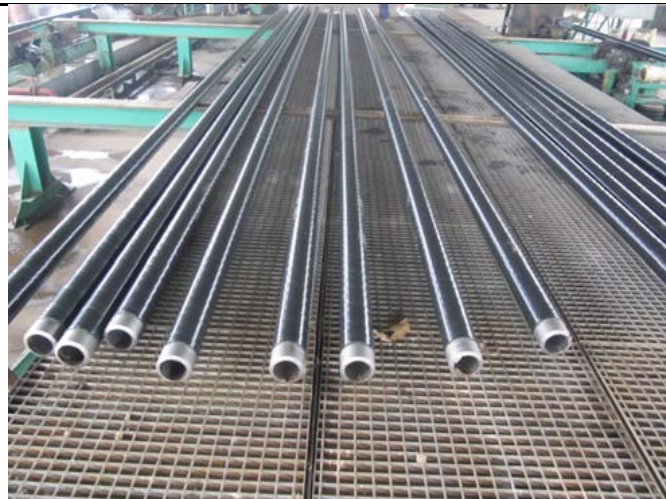
Visual Check

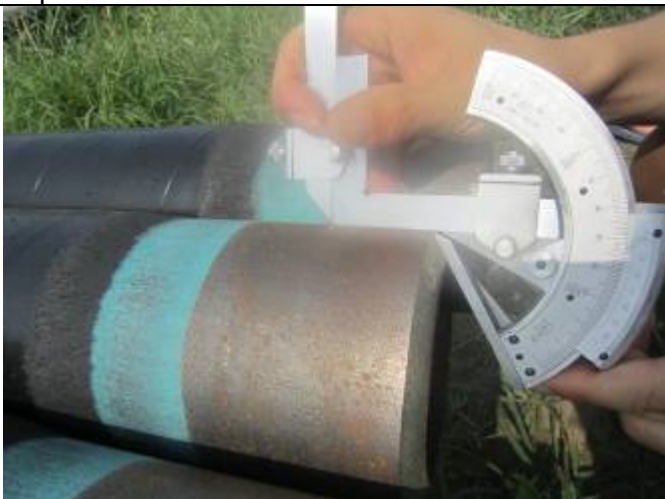
Bevel angle check

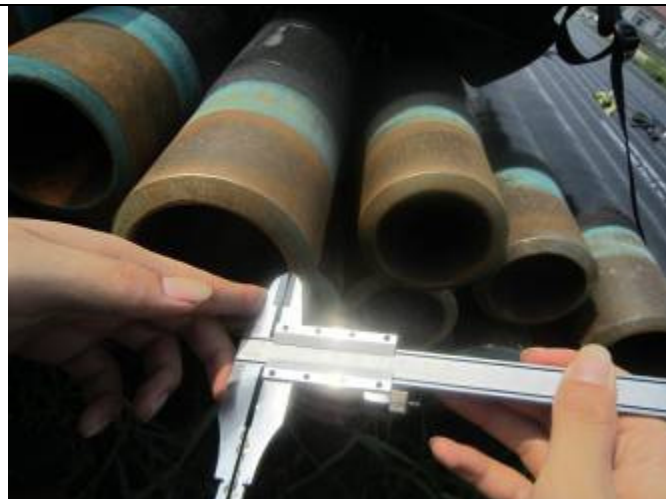
Root face check

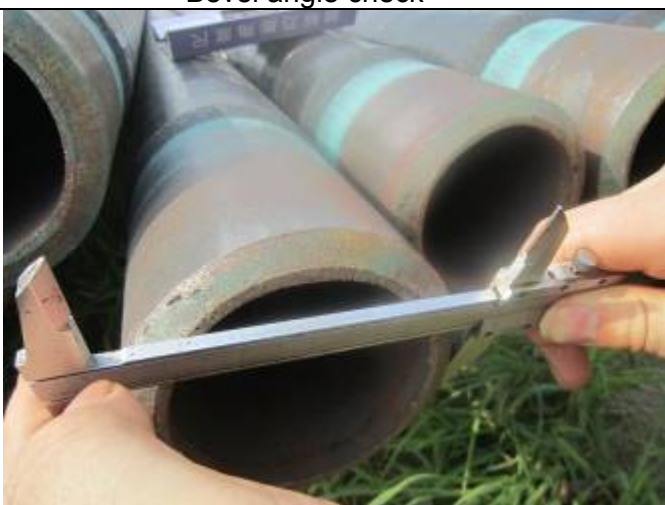
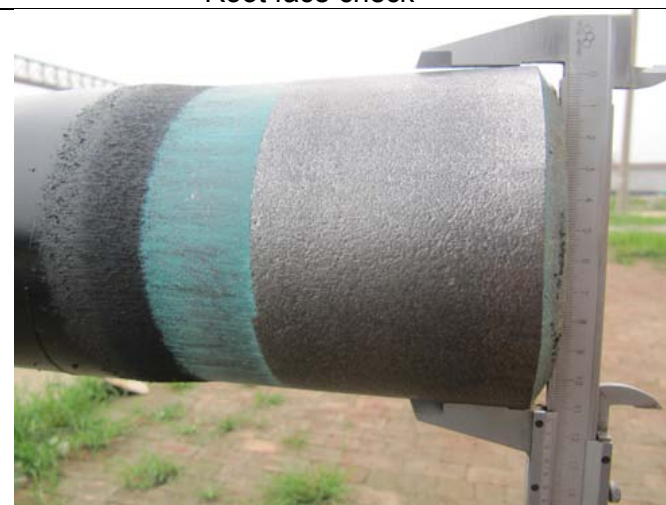
OD check

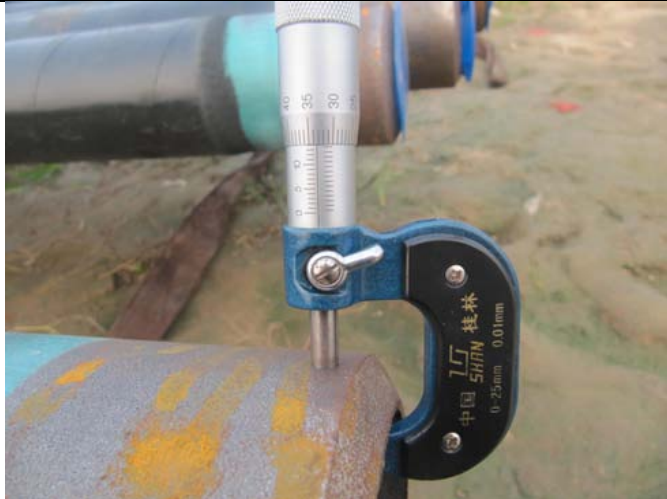
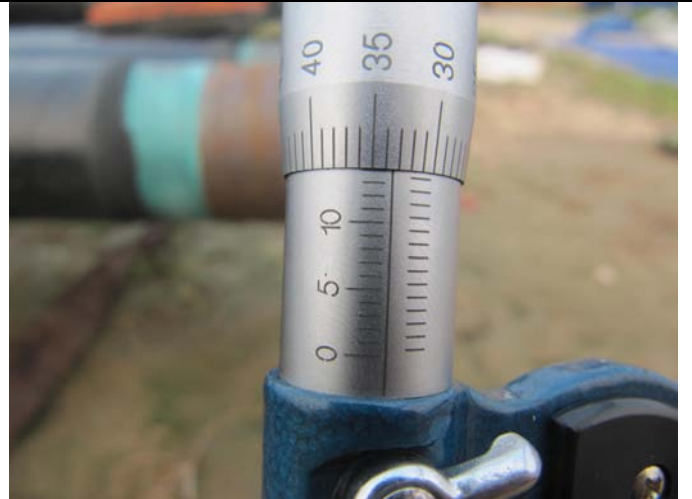
Pipe wall thickness check

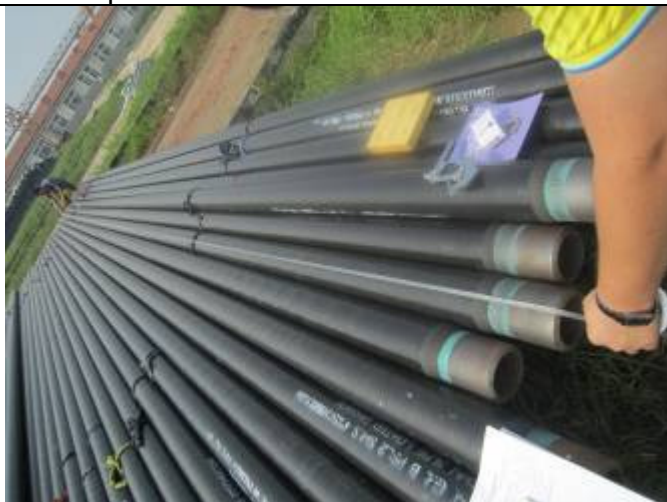
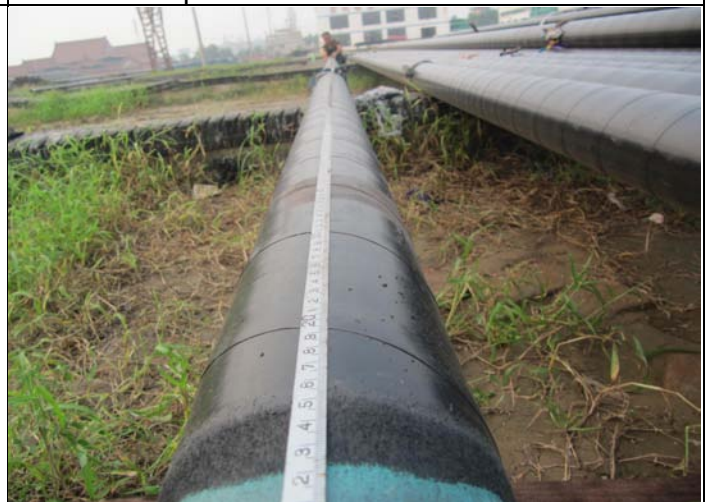
BV inspector checked the pipe OD, wall thickness, bevel angle, root face and length. Each pipe length is 11.8m except the pipe for material test sampling. The length of the sampling pipe is 11.0m checked by manufacturer after BV inspector left factory. The inspection result is acceptable. Table of dimension is as follows:

Pipe length check

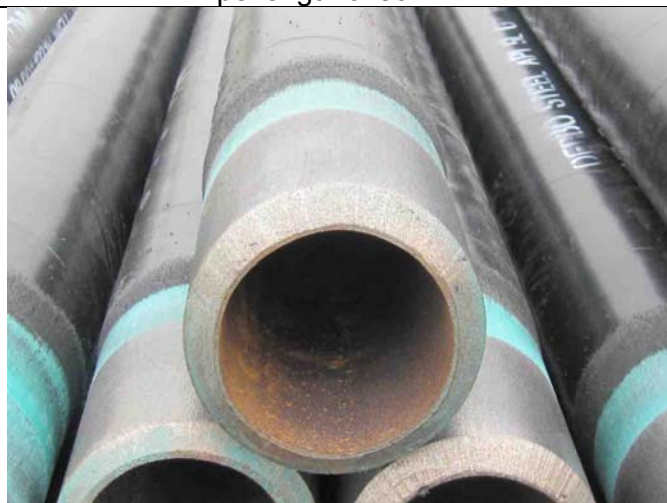
Pipe end surface quality

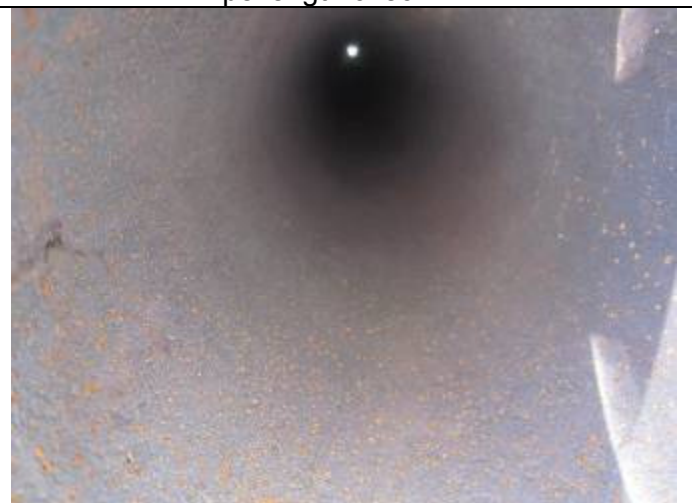
Pipe inner surface quality

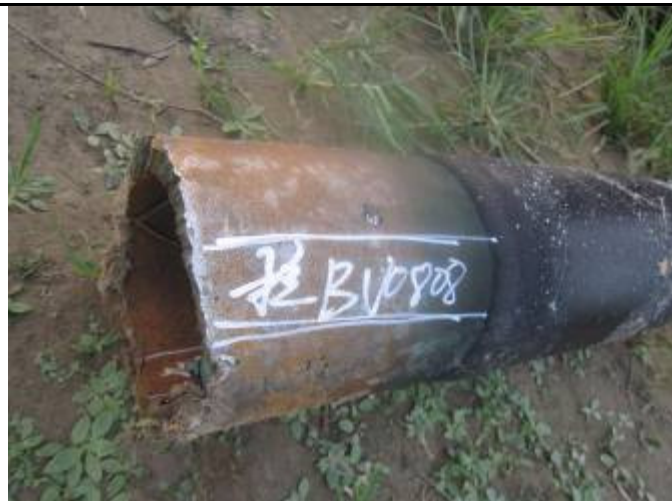
Test sample was cut from pre-reserved pipe by factory, the pipe no is 084. BV inspector witnessed the sampling process, and then the sample was sent to mills laboratory for specimen manufacturing.

Sample

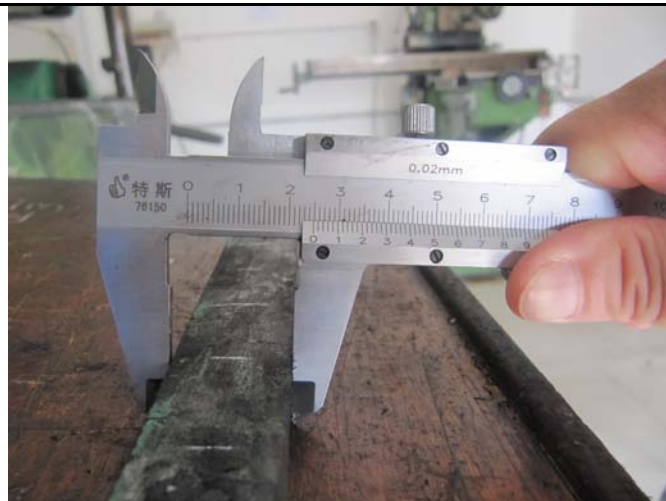
Specimen dimension check

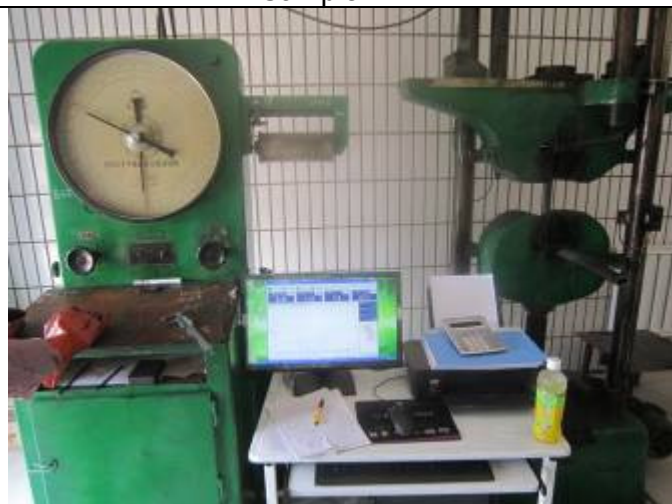
Tension test

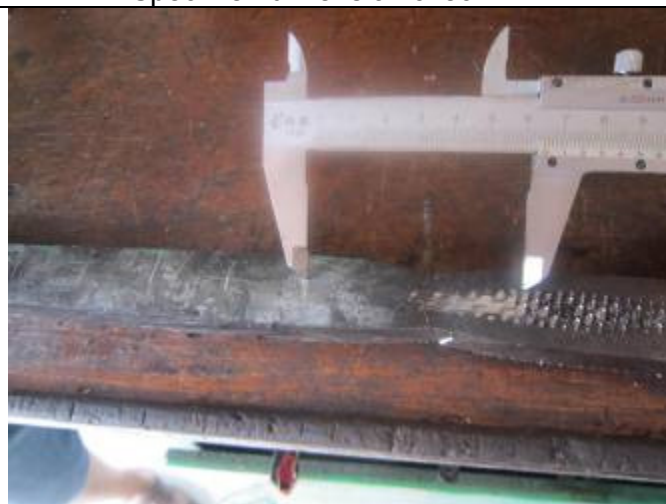
Elongation check

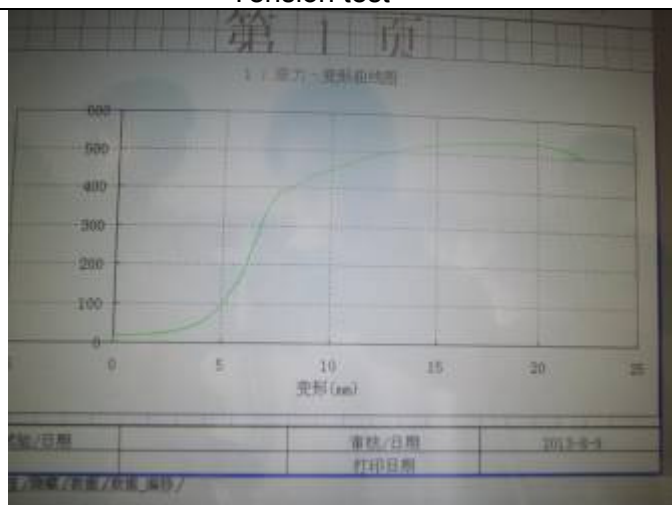
Tension test graph display

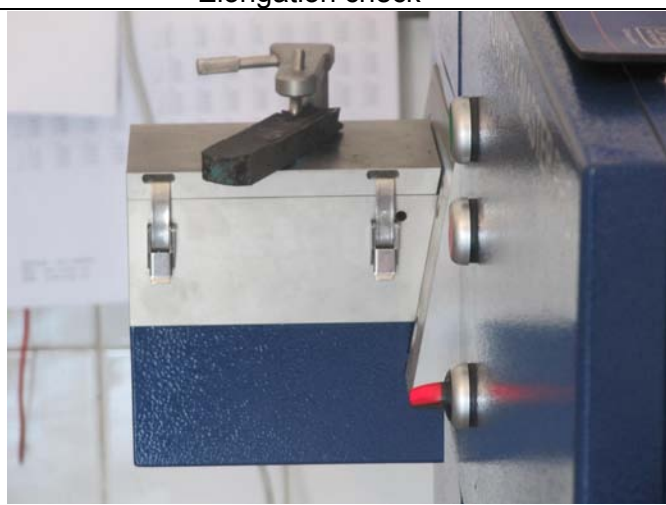
Chemical analysis test

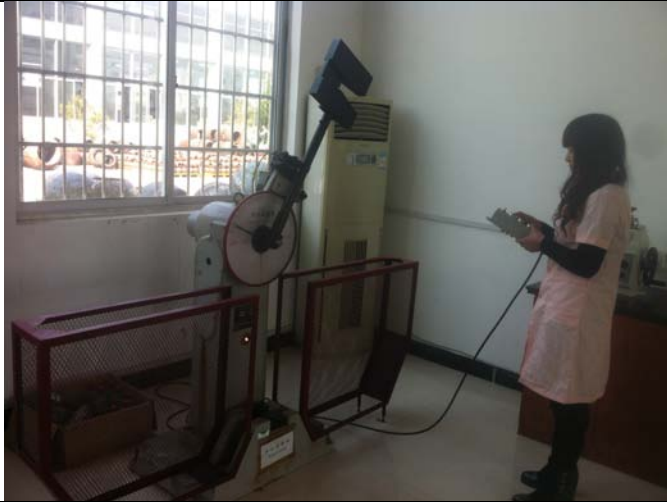
Impact Test

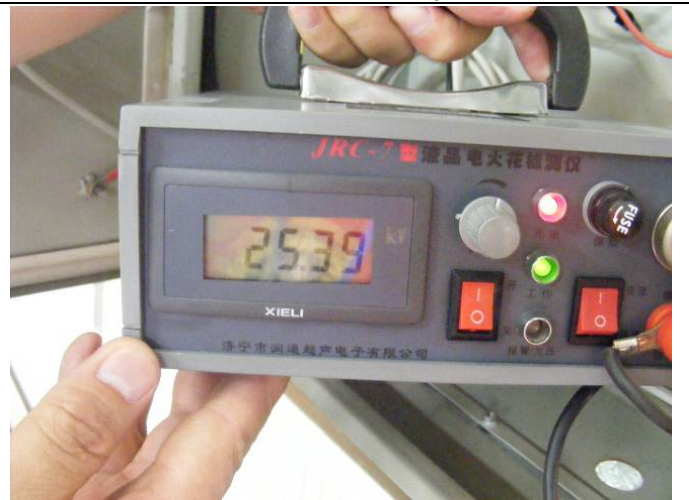
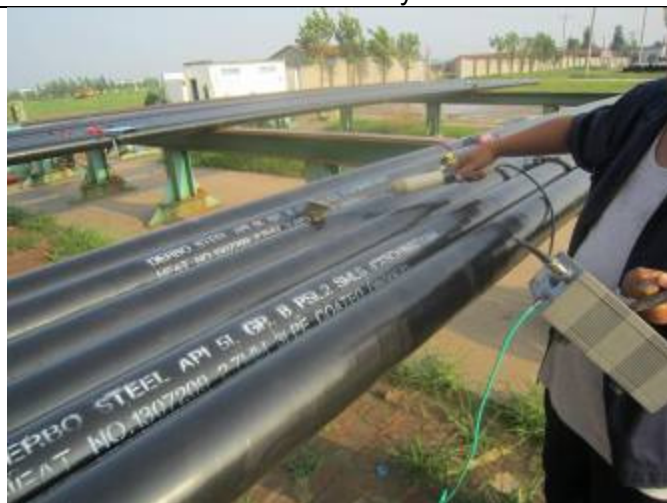
Holiday Test

Holiday test

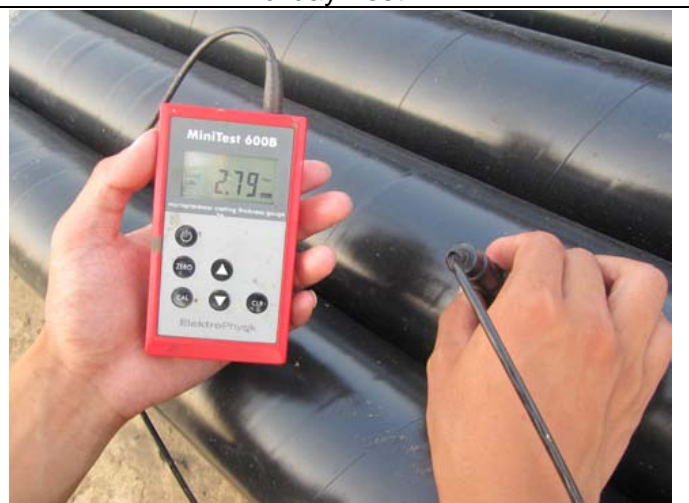
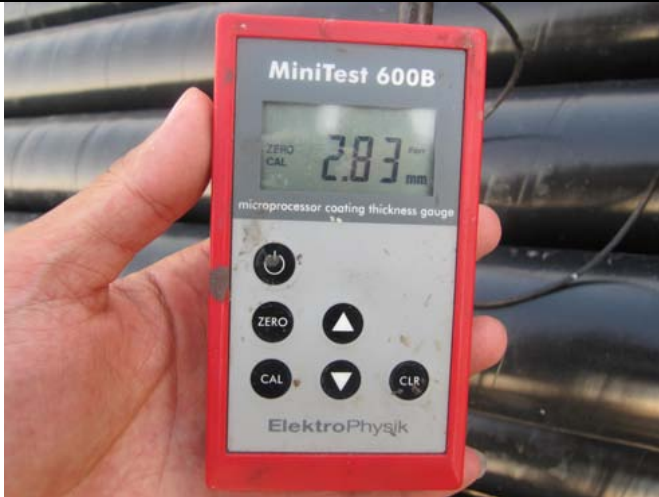
Coating layer thickness check

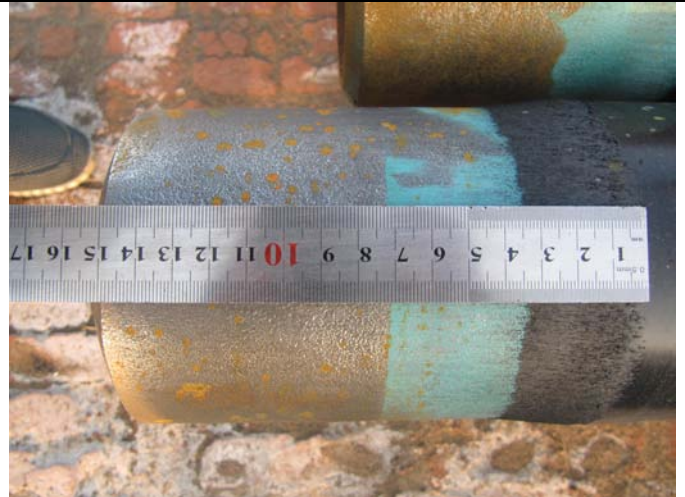
Cut back length check

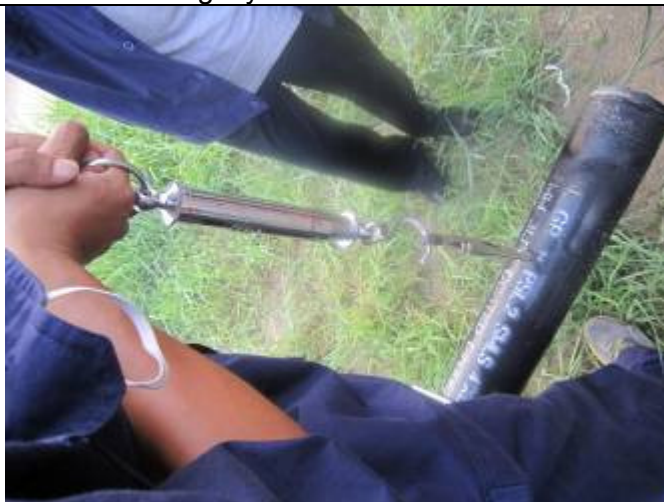
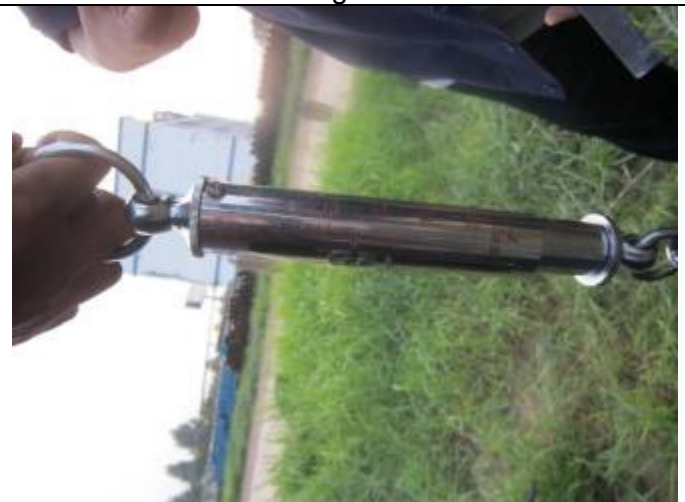
The peeling test was performed on sampling pipe(pipe no:084), the test result is acceptable.

Peeling test
