INSPECTION REPORT IDD/B-09/093-02

PROJECT: TPI for Seamless Carbon Steel Pipe**Ref:** L/C NO: 0070609018**BV Client:** Chengdu Derbo Steel Co.,Ltd.**P/o nr:** IDD/B-09/093

SUPPLY / SUBJECT OF INSPECTION	MT	PCS
SEAMLESS PIPES AS PER ASTM A 106 GR.B		
168.3mmx5.56mmx5.8m	13.0	102
355.6mmx7.92mmx5.8m	80.0	204
406.4mmx9.53mmx5.8m	38.6	72
Total	131.6	378

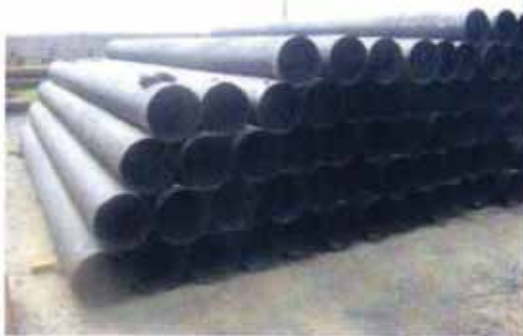
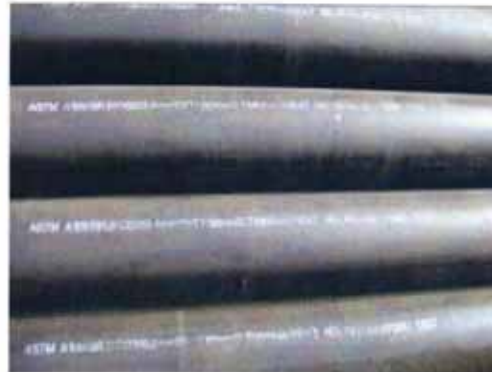
This inspection performed random at 10% rate. During inspection, BV inspector found all pipes were stacked on hypaethral ground, the surface of pipes were covered with black coating, few of pipes were painted marking,

Remark: The marking without completely finished, the manufacturer said they will finish it when loading.

Marking example: ASTM A 106 Grade B, 355.6MM*7.9MM*5.8M, 895449, HYDRO TEST

Visual inspection and marking example

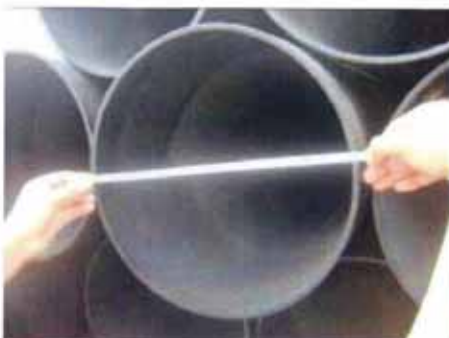
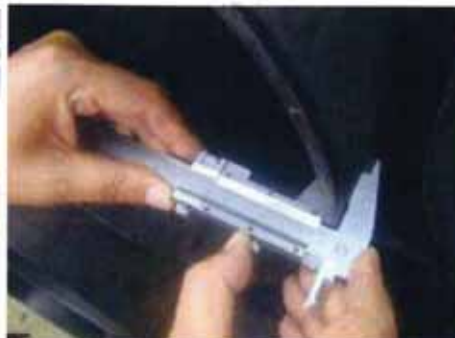
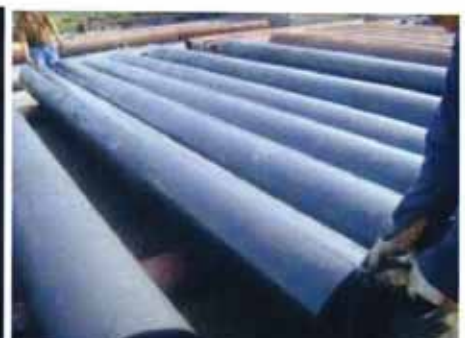
This inspection was performed randomly at 10% rate. The result is acceptable.

Type		Outside diameter	Wall thickness	Length
168.3X5.56mm	Required value	168.3 (+1.6/-0.8)	5.56 (+22.5%-12.5%)	5.8 m
	Actual value	167.6-168.3	5.1-5.8	5.805-5.825
355.6X7.92mm	Required value	355.6 (+2.4/-0.8)	7.92 (+22.5%-12.5%)	5.8 m
	Actual value	355-358	7.3-8.6	5.803-5.815
406.4X9.53mm	Required value	406.4 (+2.4/-0.8)	9.53 (+22.5%-12.5%)	5.8 m
	Actual value	406-407.5	8.4-9.6	5.84-5.85

Outside diameter, wall thickness and length inspection

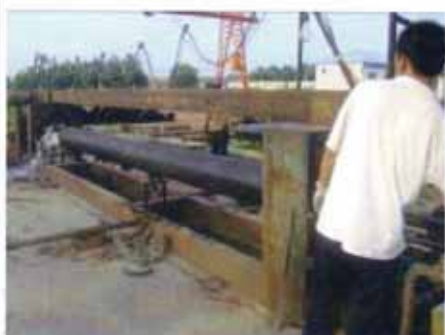
Filling water

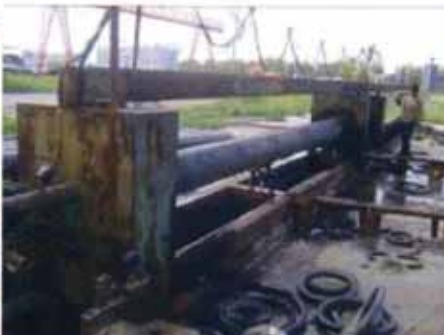
Pressurizing

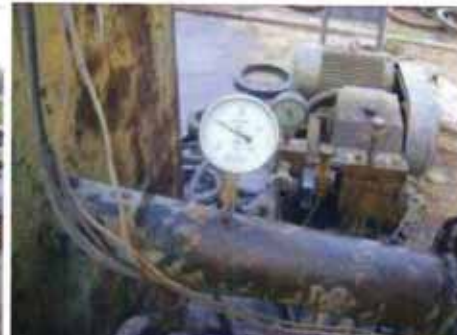
This hydrostatic test was witnessed by BV inspector at 10% rate random. After inspection the result is acceptable.

Type	Test pressure	Duration	Result
168.3X5.56mm	10.0 Mpa	≥ 5 sec.	Acceptable
355.6X7.92mm	6.5 Mpa		
406.4X9.53mm	7.0 Mpa

pressure gauge

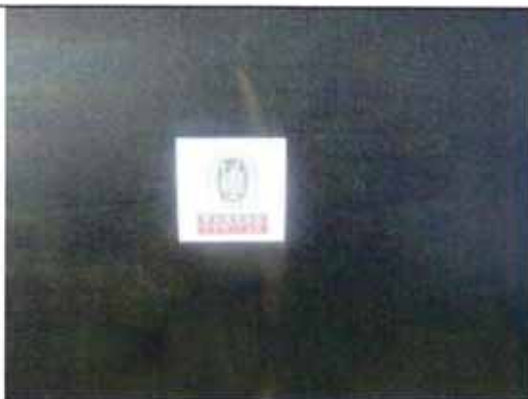
Based on above evidence, the result of this inspection is satisfactory. BV stickers were on the sampling pipes.
