Page: 1/6  <input type="checkbox"/> Interim <input checked="" type="checkbox"/> Final
<b>INSPECTION REPORT N° IR INS/SW-CD-14/040</b>		
<b>BV Job nr:</b> INS/SW-CD-14/040

<b>PROJECT:</b> Third Party inspection For CHENGDU DERBO STEEL CO.,LTD	<b>Ref:</b> INS/SW-CD-14/040
<b>BV Client:</b> CHENGDU DERBO STEEL CO.,LTD	<b>P/o nr:</b> N/A <small>(client to BV)</small>
<b>Manufacturer:</b> HENGYANG VALIN STEEL TUBE CO., LTD	<b>P/o nr:</b> <small>(client to Manufacturer)</small>
<b>Inspection requested by:</b> CHENGDU DERBO STEEL CO.,LTD

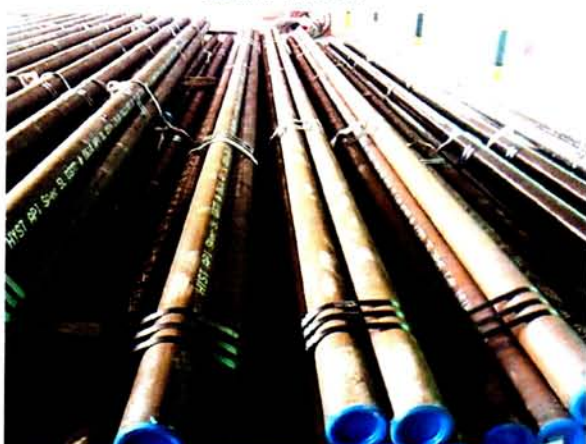
Above 10% visual inspection for pipes was performed at site. There was no any unacceptable defect was found. The pipes were beveled ends with plastic caps protected. The marking was checked as well and found acceptable.

Visual check

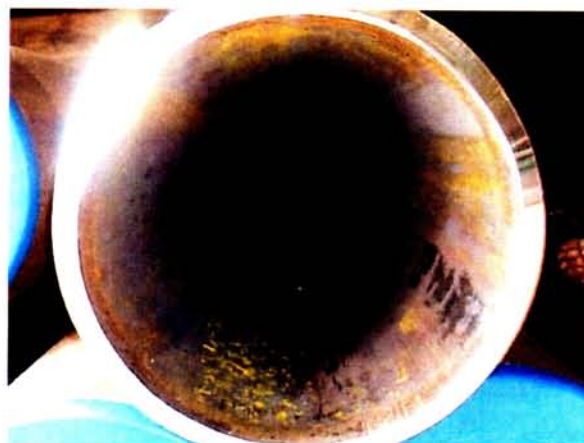
Visual check

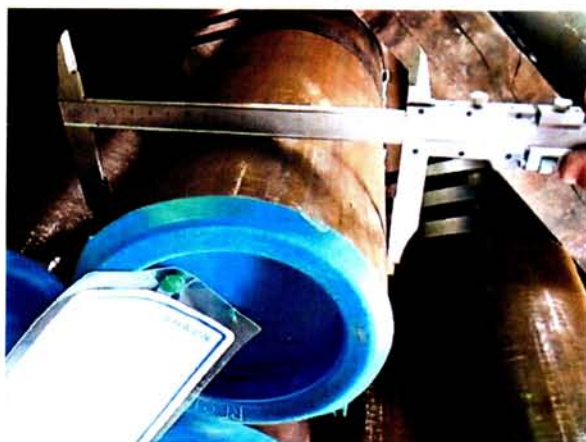
Randomly above 10% dimension checking included outside diameter, wall thickness and length of the pipes was carried out at site. The inspector witnessed the measurement and found the result was acceptable according to the requirement of specification and PO.

OD check

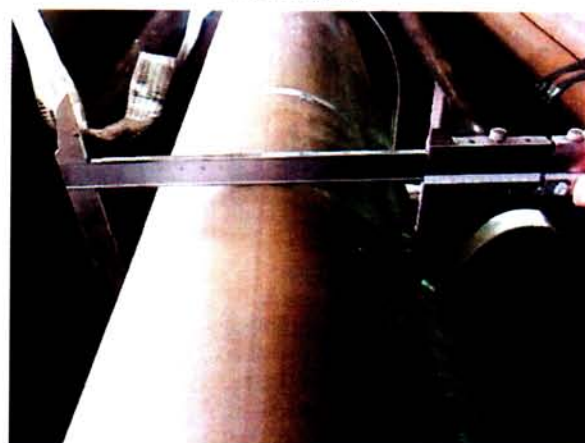
OD check

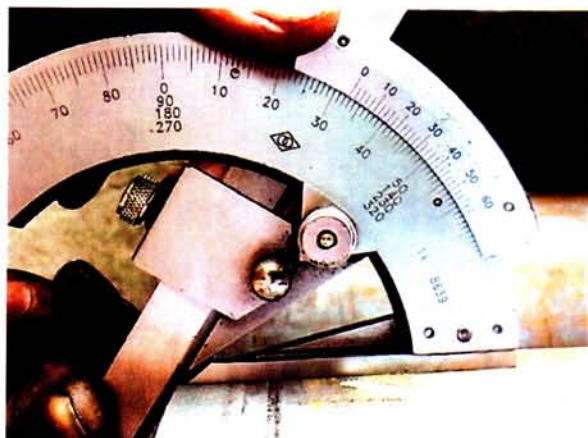
The bevel for the end of pipes had been checked as well. The angle and root face had been checked and found acceptable.

Bevel check

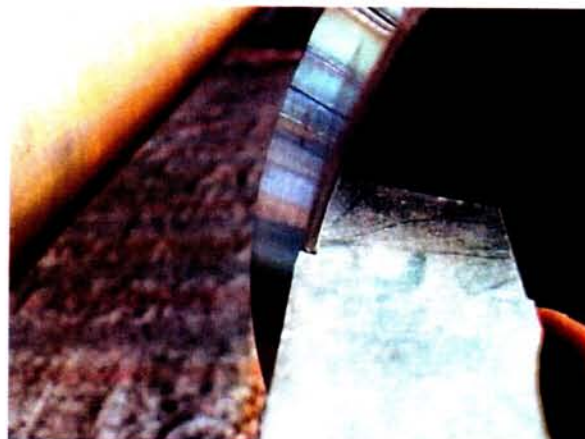
Edge check

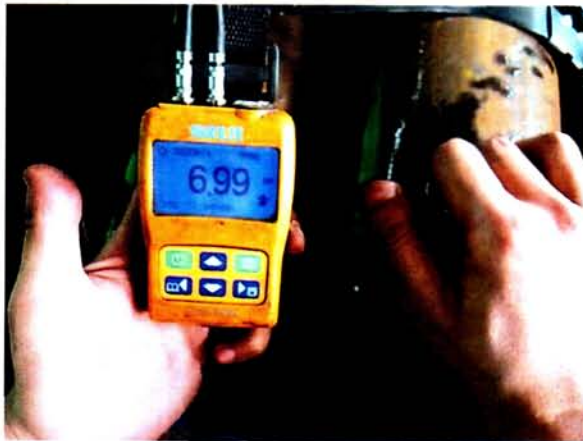
Wall thickness check

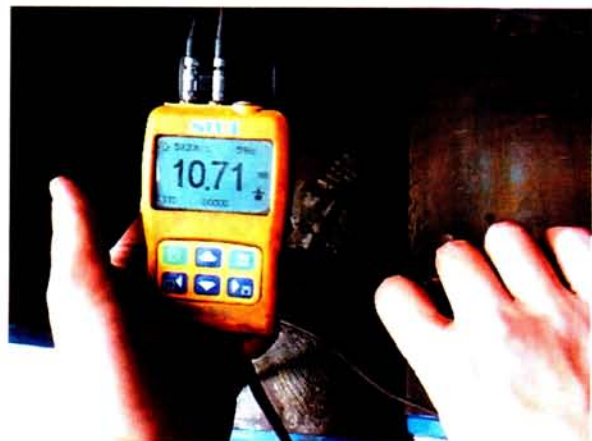
Wall thickness check

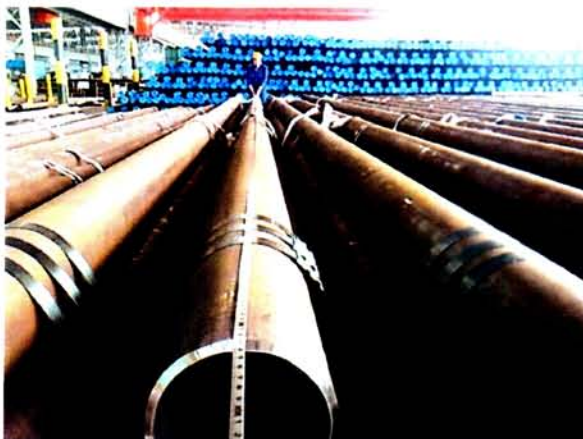
Length check

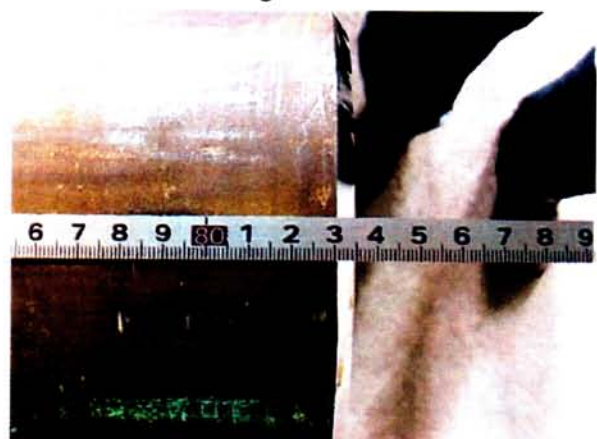
Length check

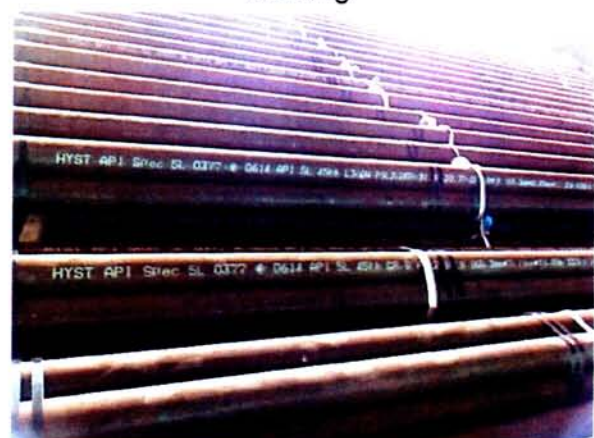
Marking
