TEST REPORT

No. : XMIN1708005234PS

Sample Name : ABS LOCKER
Manufacturer : Xiamen Toppla Material Technology Co., Ltd.
Material and Mark : ABS+HIPS

Summary of Results:

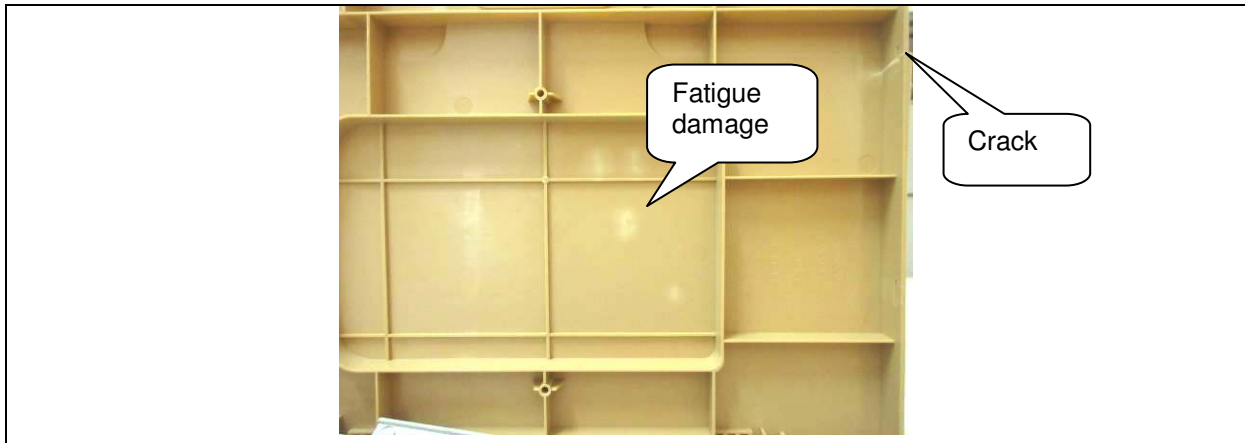
Specimens identification No.	1	2
Drop height (damage occurred), h(mm)	1500	1400
The crack length (mm)	30	31
Description of the damage and the position of the crack	Fatigue damage can be observed at the back of impact point, and see the photo of position of the crack, both of the cracks almost at the same position.

After test- Back of the plastic locker door

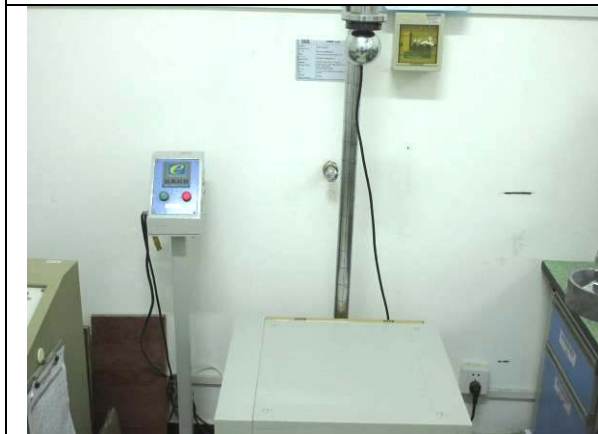
Test position2: the centre of the plastic locker side face

During test-The centre of the plastic locker side face

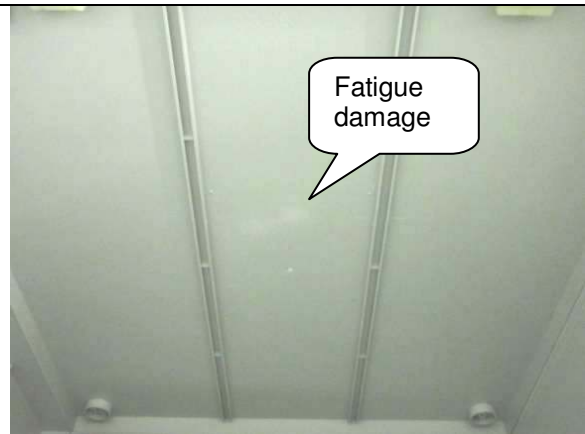
Specimens identification No.	1	2
Drop height (damage occurred),h(mm)	1500	1500
The crack length (mm)	0	0
Description of the damage	Fatigue damage can be observed at the back of impact point.

After test- Back of the plastic locker side face
